Damage to Athonite monasteries after nearly two years of earthquakes

Damage to arches and vaults, domes and cupolas, chimneys and masonry are among the problems recorded in inspections carried out at Mt. Athos monasteries following a long series of earthquakes.

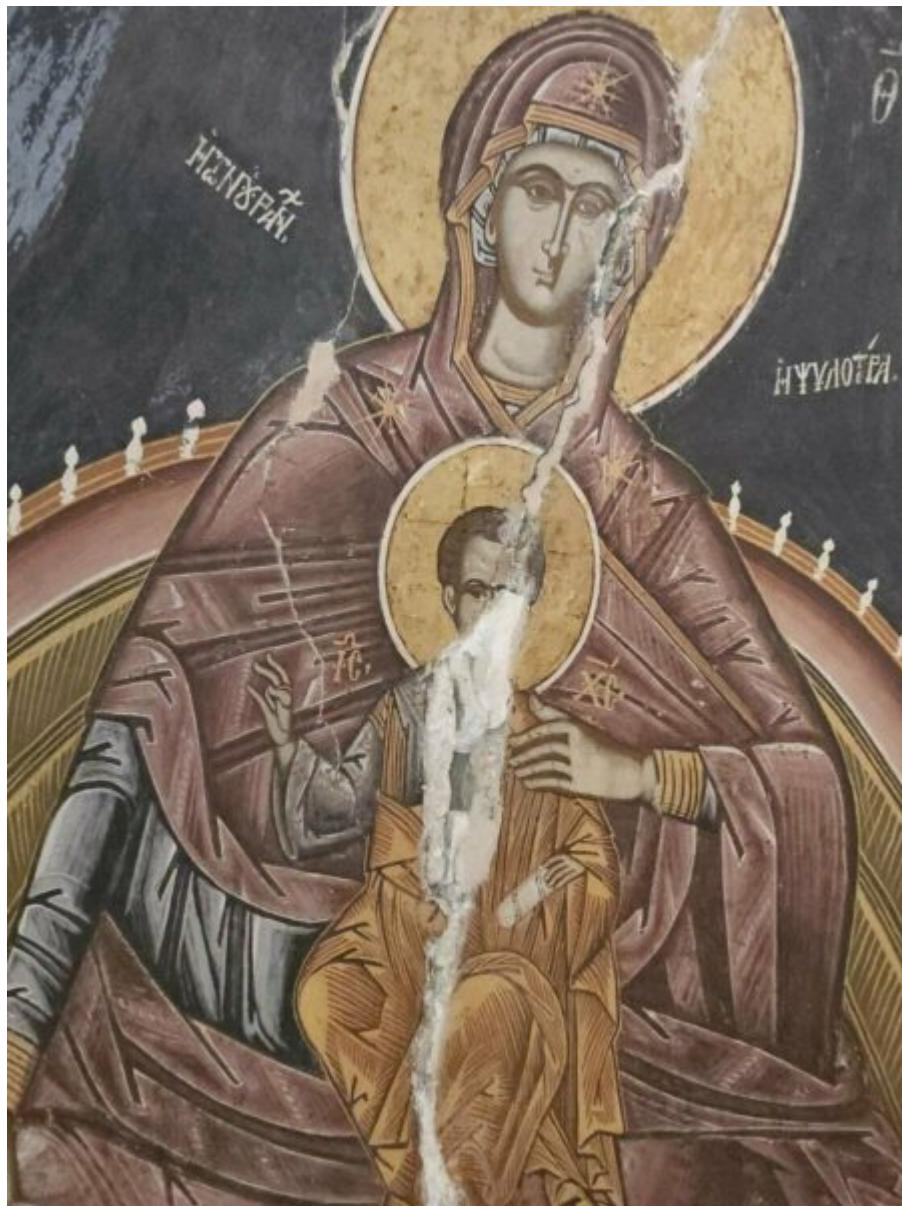
Damage at Dochariou Monastery. Photo: Ministry of Culture

10. Dochariou Monastery: Cracking in vaults, arches and stone masonry

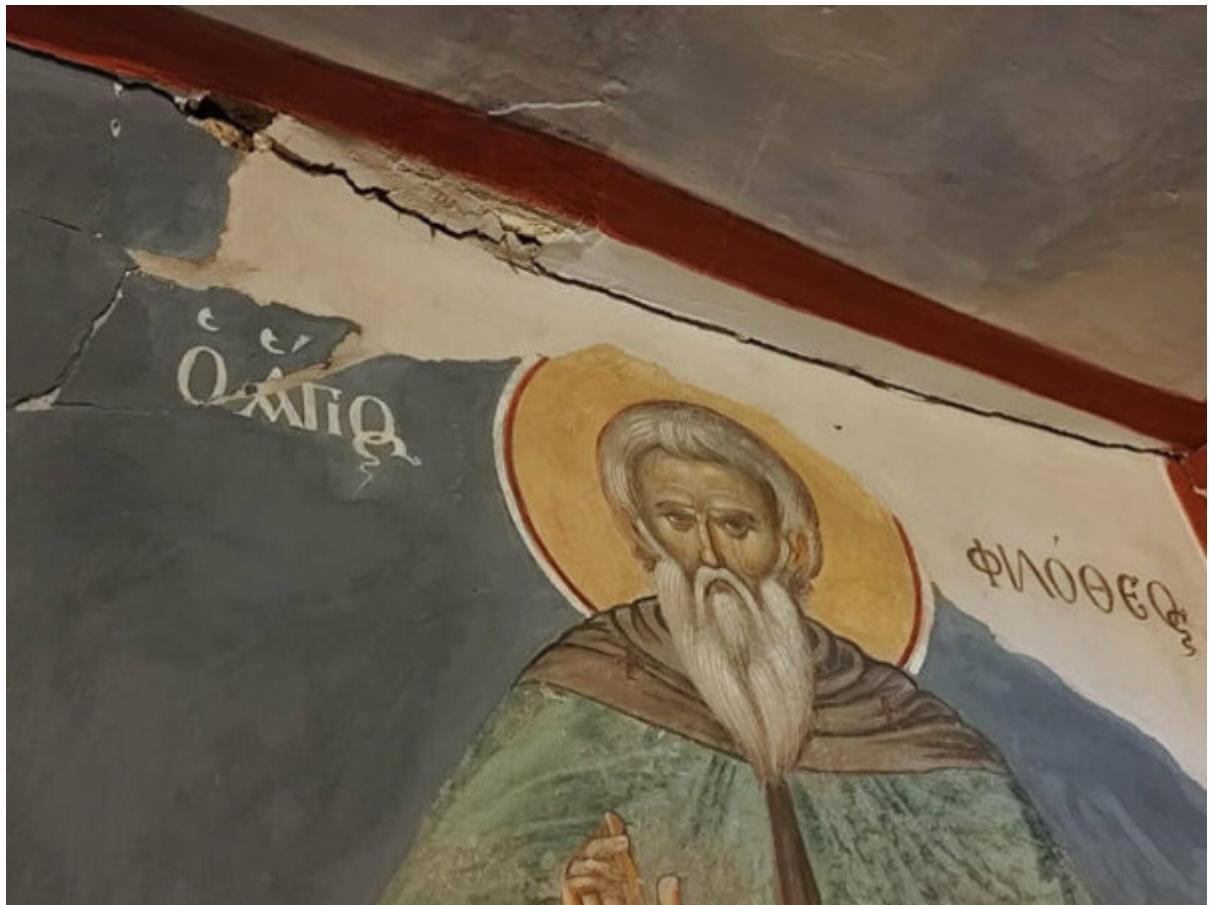
Damage at Xenophontos Monastery, St. Euphemia Chapel. Photo: Ministry of Culture

14. Xenophontos Monastery: Cracking in tympana of domes. Detachment of plaster. Worsening of previous cracking.
