## Roof over Saint Sava Cathedral takes form

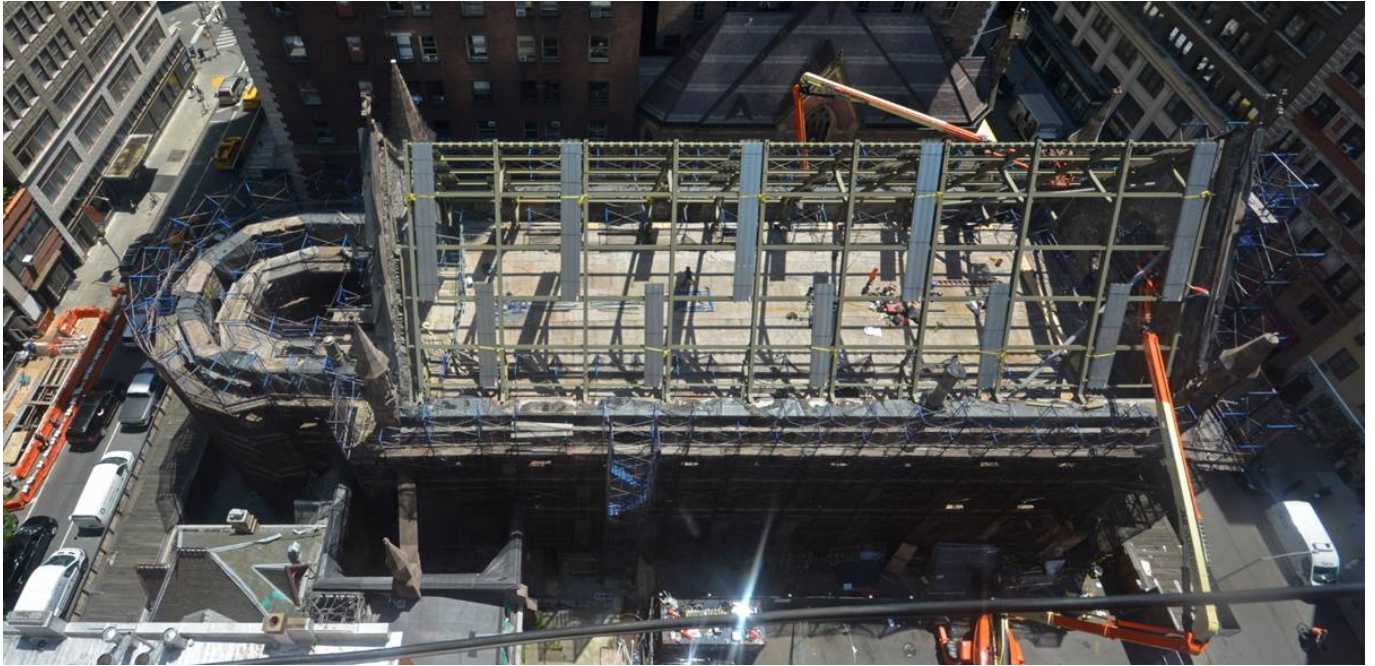
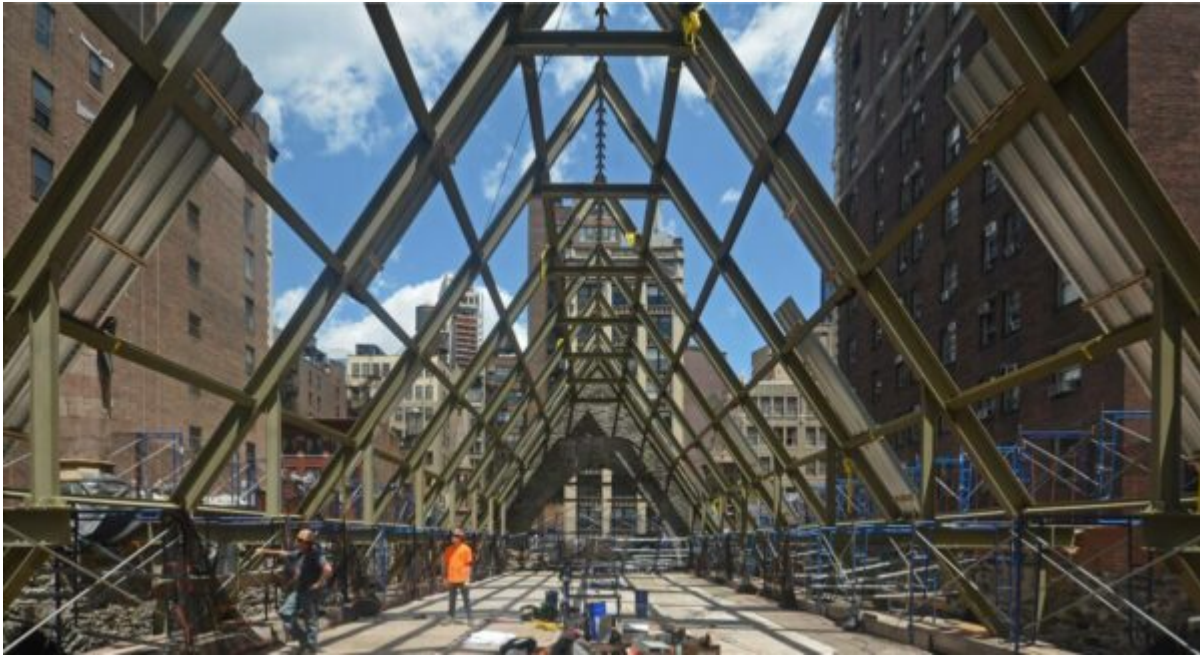
The principal steel roof trusses are now in place, bolted and welded, tying together the previously freestanding historic stone walls. With the imminent installation of the metal-deck roof covering – presently stacked on the roof framing and ready for distribution, as seen in the photos – the trusses will become further braced laterally, thereby contributing to the general stability of the building as a whole.

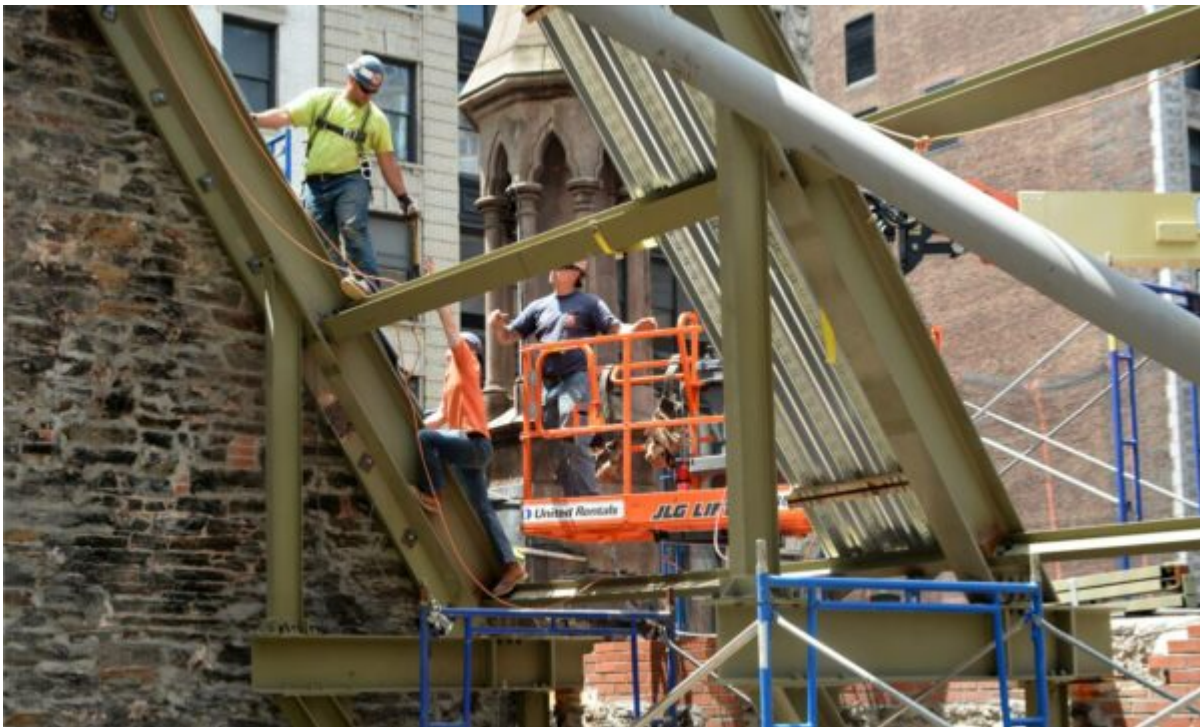
There has been much preparatory work, of course, to be able to get to this part of the reconstruction work: including the removal of large piles of post-fire debris and dangerously weakened inside decorative-Caen stone facings (a Jurassic limestone quarried in north-western France near the city of Caen, formed in shallow water lagoons in the Bathonian Age about 167 million years ago!), as well as the painstaking repair and reinforcement of the remaining, structural granite and brown stone walls and the preparation of their top surfaces to receive the new roof-framing.
